**Meeting Date:** 31 May 2016**Subject:** Redwood Trees Te Kuiti Esplanade**Purpose of Report**

## ARBORICULTURAL REPORT

<b>Title</b>	<b>Te Kuiti Coast Redwoods (Sequoia) Assessment</b>
<b>For</b>	<b>Liz Riley - Waitomo District Council</b>
<b>Site</b>	<b>120 Esplanade, Te Kuiti</b>
<b>Prepared By</b>	<b>Erika Commers - Treescape Environmental</b>
<b>Reviewed By</b>	<b>Jon Redfern - Treescape Environmental</b>
<b>Brief</b>	<b>Health and safety assessment of a redwood grove</b>
<b>Date</b>	<b>22 April 2016</b>

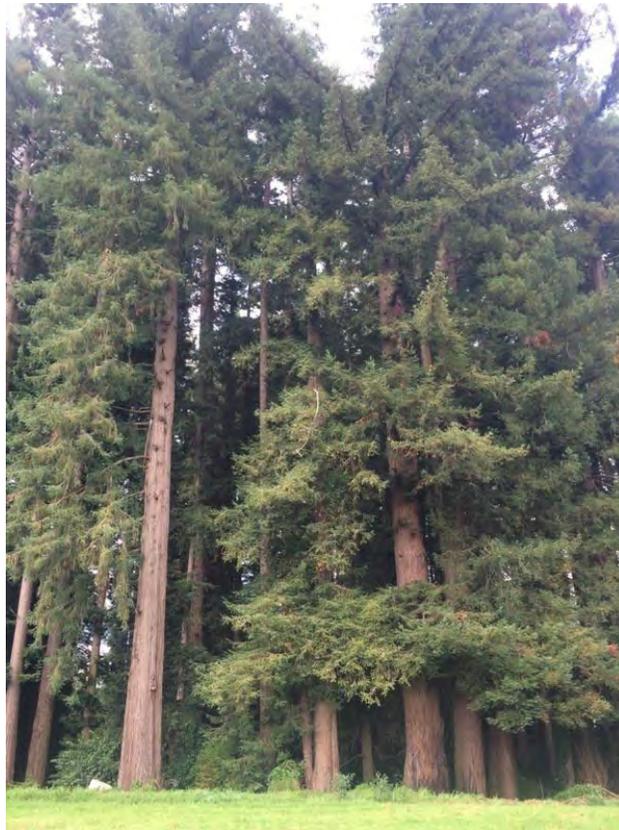
Crown cleaning occurred to the lower bole of the outer trees here due to dieback.

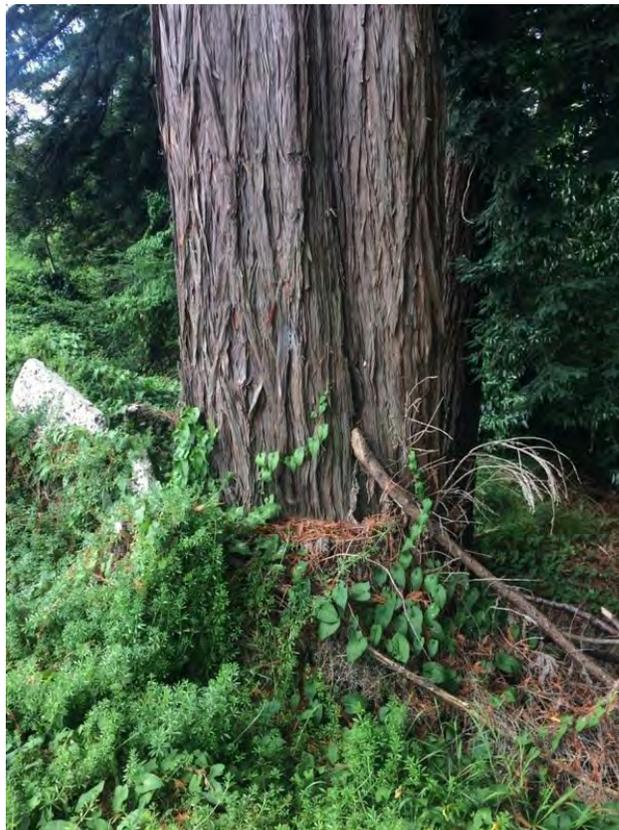
Large concrete debris and backfill to 70 cm at the north side of this stem

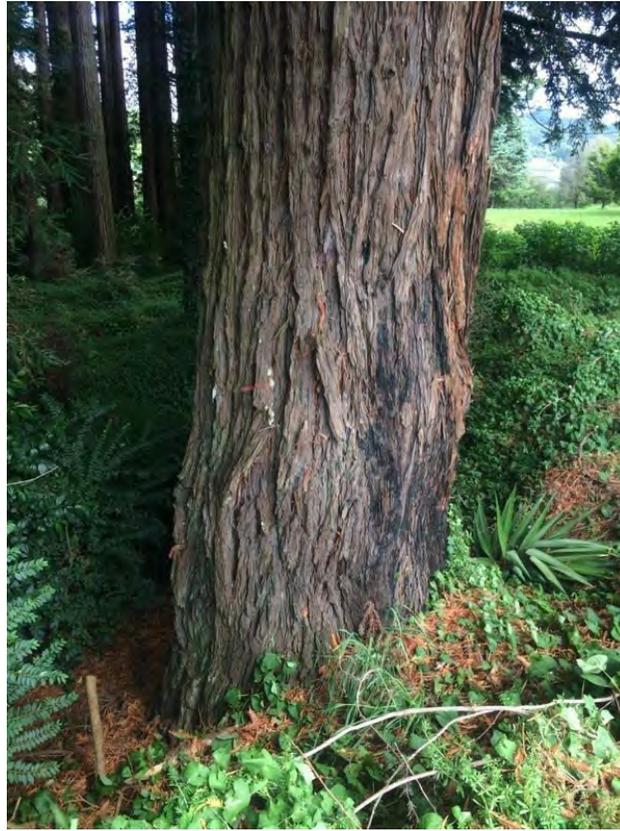
Possible burn scar and backfill at the north

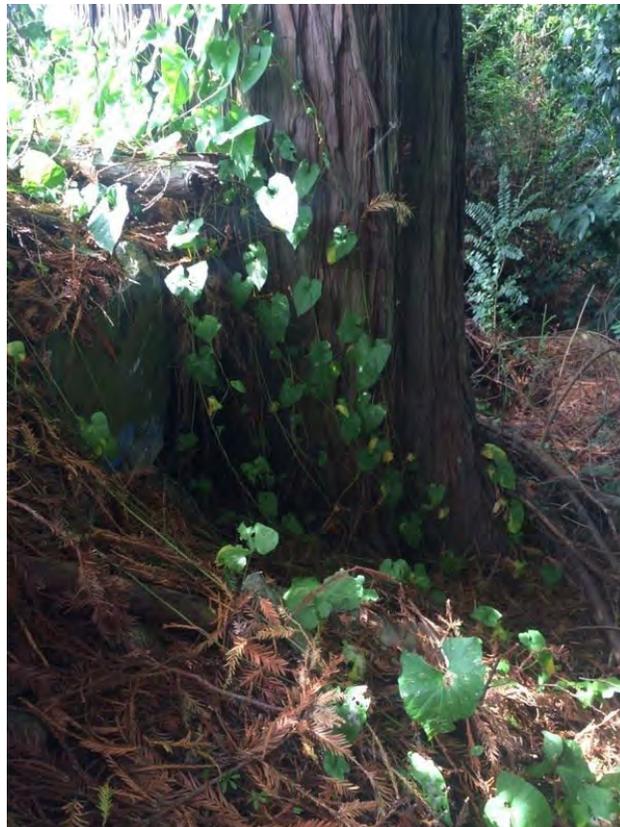
Fill level depicted at right (north) with large debris resting against tree's main stem.

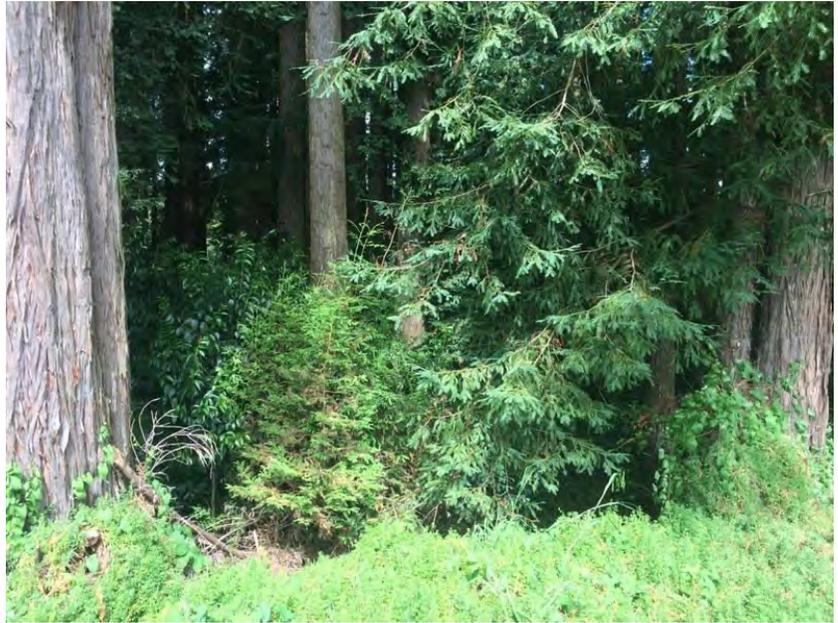
Stump of a removed tree with 'fairy ring' shoots from the lignotuber

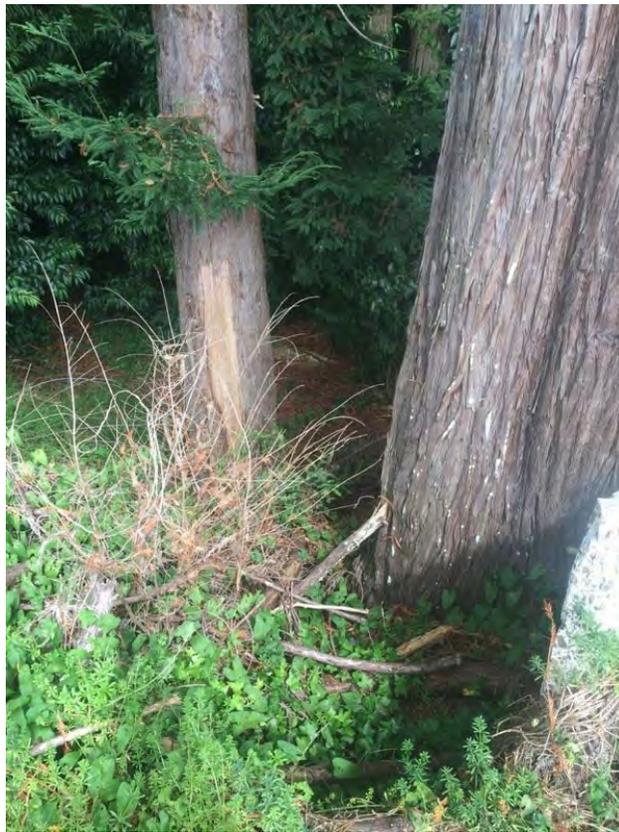
- iii. Main stems appear entirely intact on each of the trees in this area; there is one noticeable region of bark loss on the smallest tree, it was likely caused by the removal of the neighbouring tree and appears to be fairly superficial with no cambium exposure. There are no further detected cavities, splits, cracks, or cankers amid the trees of Area 1.
- iv. The presence of pest plants is very heavy in this area. Wandering jew covers the ground in a very thick knee-deep mat. Climbing ivy vines (*Hedera sp.*) have grown to various heights on many of the nearby trees, some trunks are fully surrounded. There are young privet (*Ligustrum sp.*) and Elaeagnus (*Elaeagnus sp.*) saplings growing sporadically throughout the forest floor.

Bark damage to small inner tree, stump in foreground

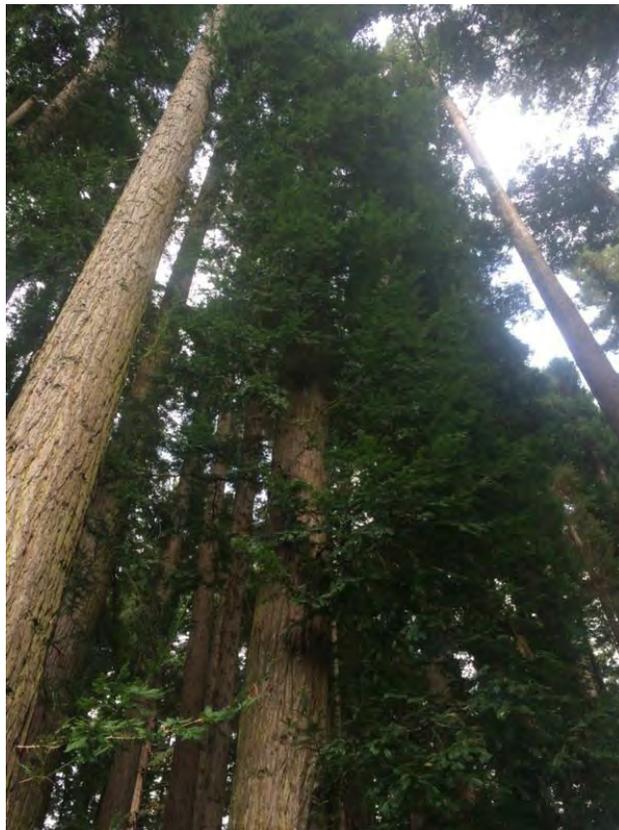
Exposed trunk of inner tree after outer tree removal, light penetration stimulated epicormic sprouting

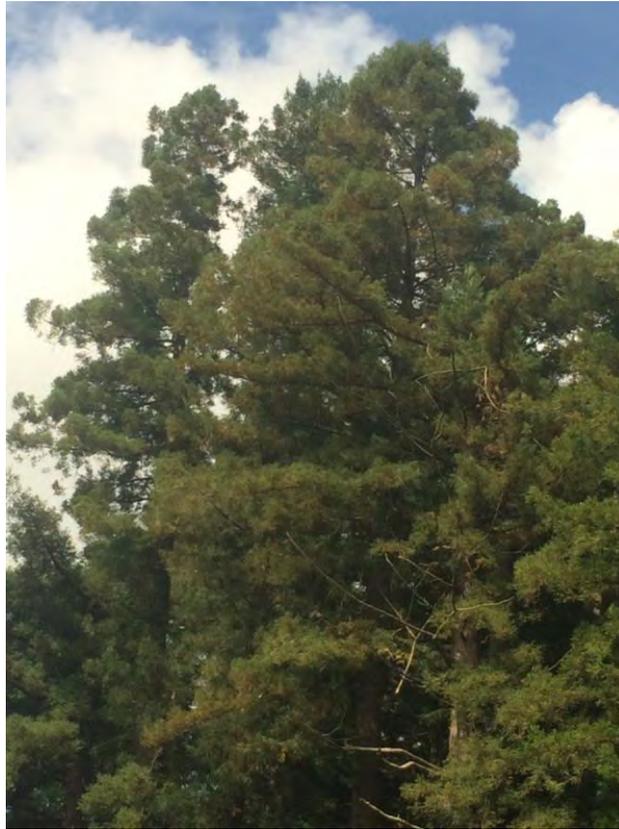
Upper canopy foliar health, some dead branched remain

- 5.3. Dead branches in the upper canopy of the north perimeter trees should be removed on a three yearly cycle. Branch senescence is a normal occurrence and dead branches have the potential to cause damage if people are present passing beneath.

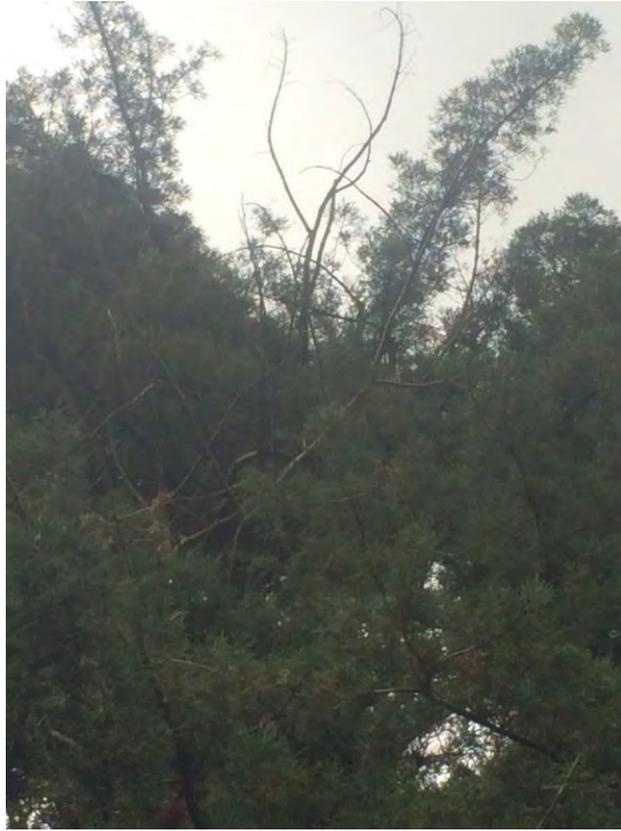
Dead attached branches in upper canopy at outer aspect

- iv. There are no noticeable cavities, splits, cracks, or cankers amid the bark of the trees. It is recommended that dead branches in the upper canopy of an individual be removed.

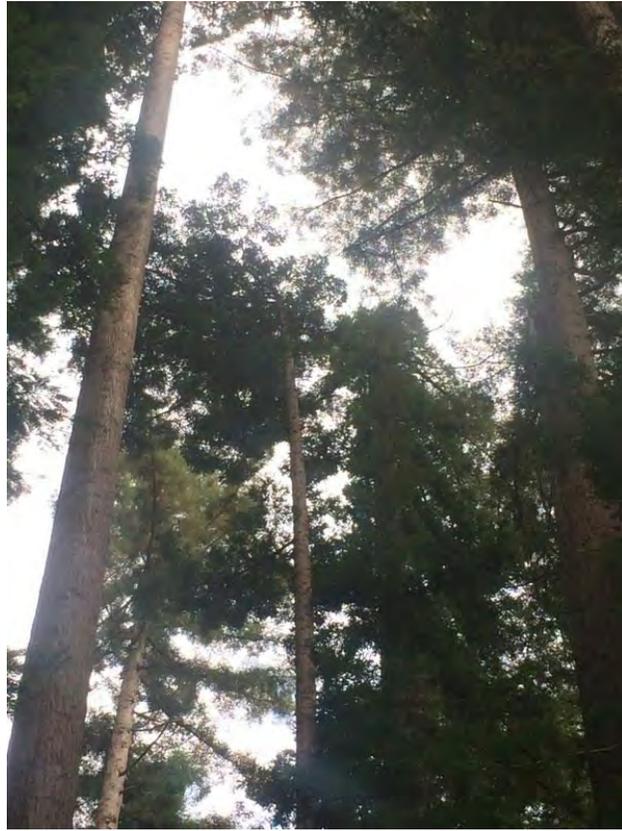
Upper canopy foliage, lost tops

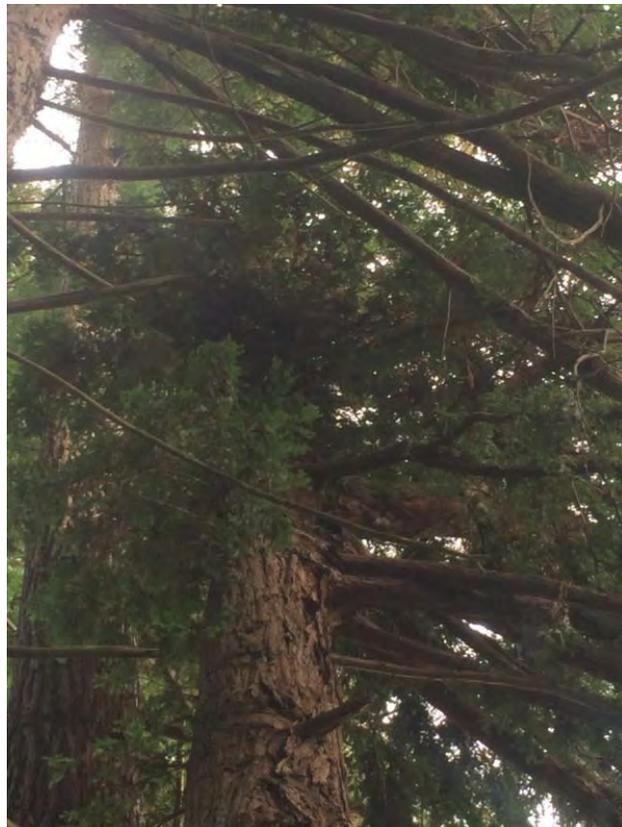
- i. There are six redwood trees addressed in this area immediately west to the trees in Area 1, most of which are located along the outer perimeter of the stand. An individual tree within Area 2 demonstrates a stem reiteration due the loss of its lead, this was also noted in the 2010 assessment. Four of the trees have previously lost their tops. In addition, there are several upper dead branches remaining in tact primarily on one individual. Alike the trees in Area 1, the trees along the outer perimeter of Area 2 have endured a grade change to the northern region of the soil environment. Fill to an unknown depth has been added over the root system at the north and up to the main stems. The appearance of canopy stress and decline is consistent with root system disruption resulting in energy and resource loss.

Lost top and reiterated trunk

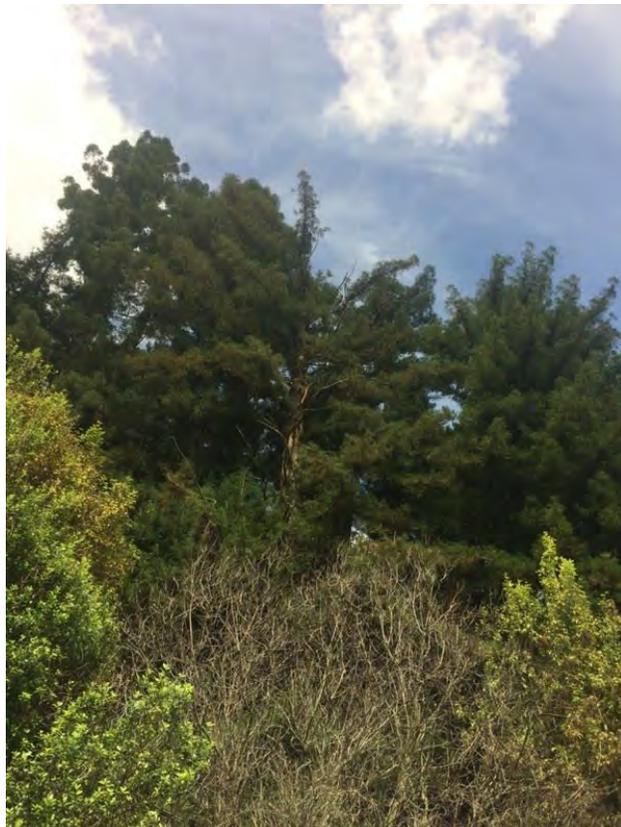
Declining upper stem in centre frame

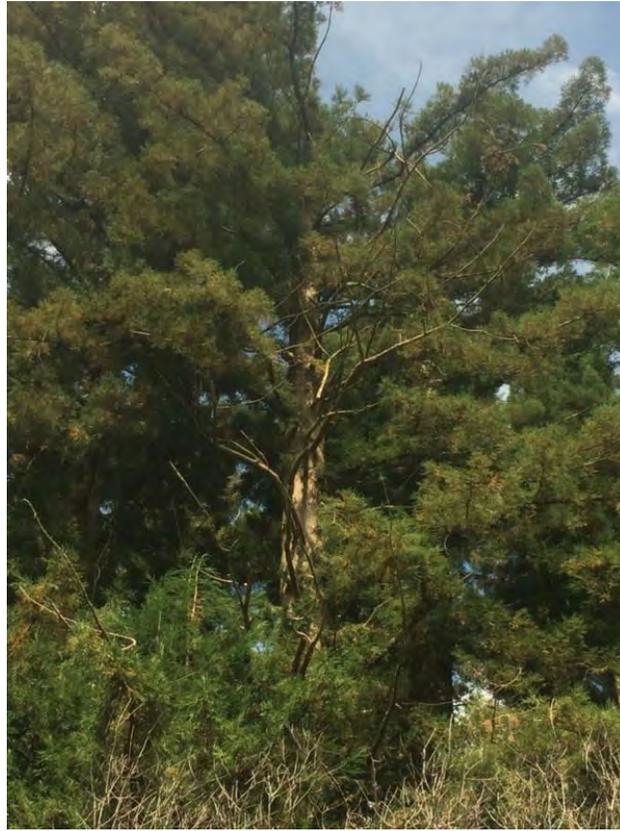
Declining stem

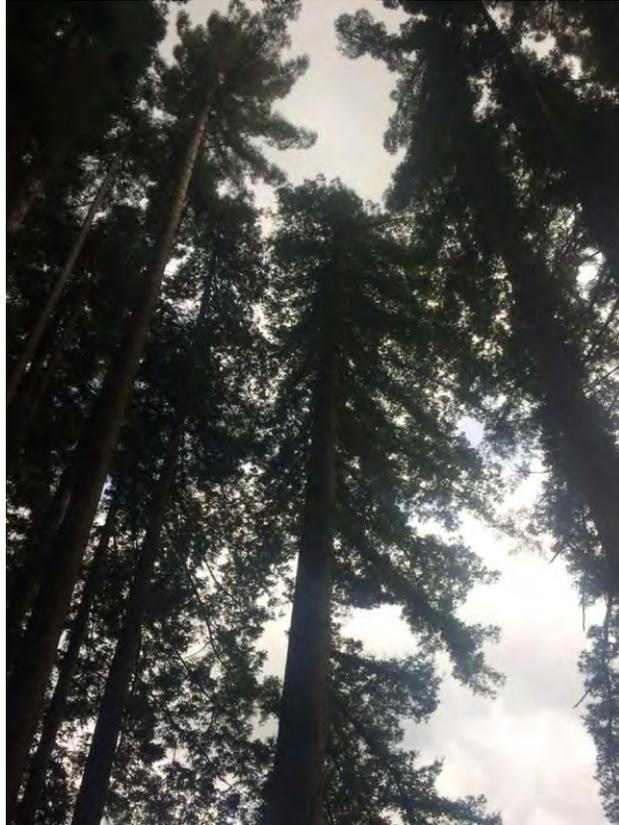
Canopy, tree with lost top

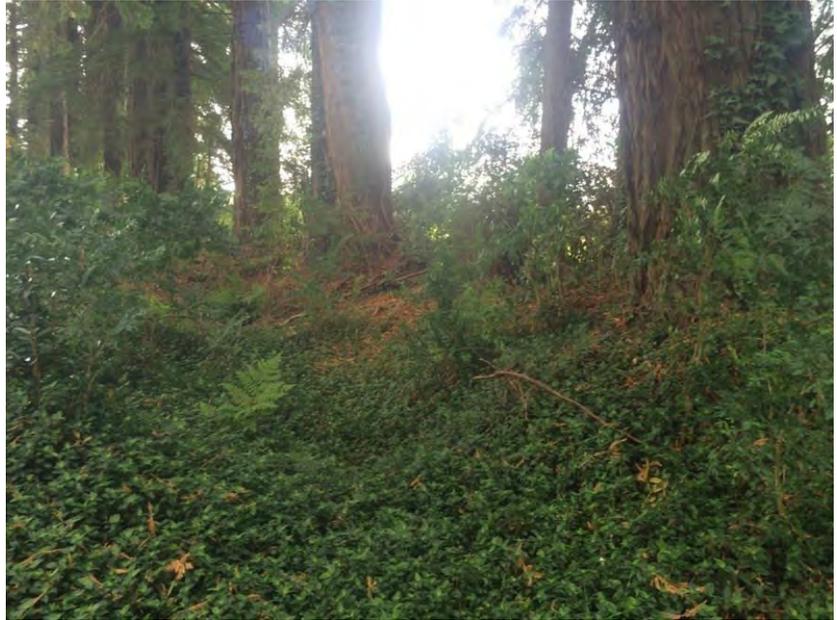
Slope of depression into valley: wandering jew, eleagnus, ivy cover

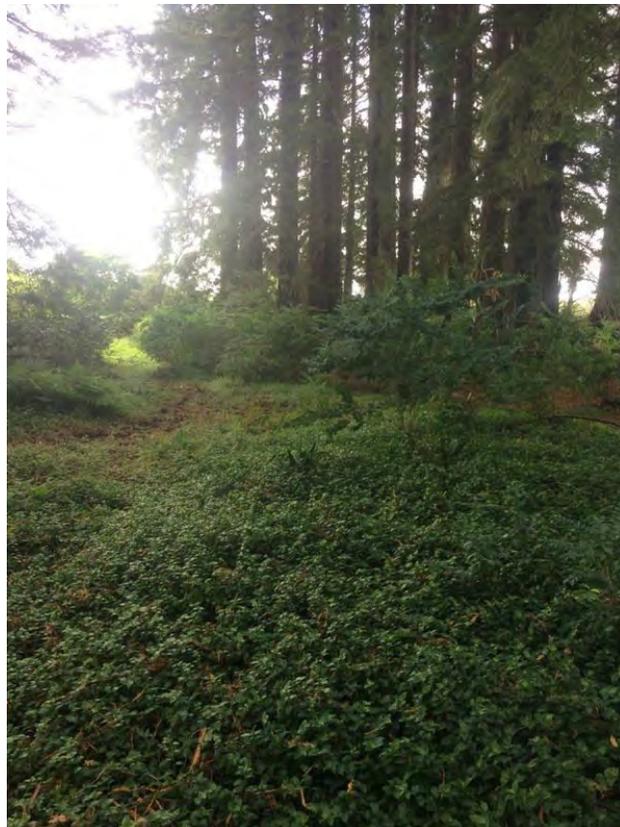
Valley covered in regrowth - pest plants. Facing east

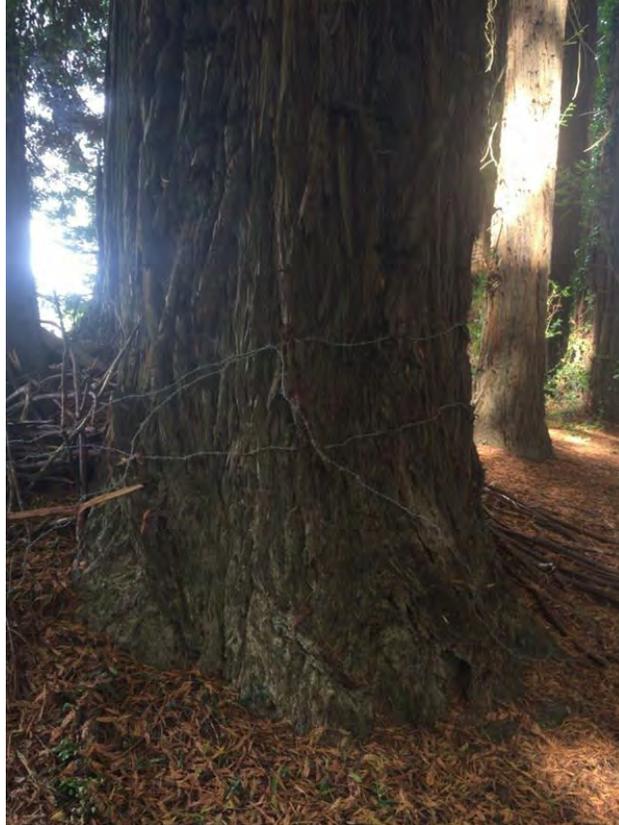
- iv. A walking path is visible from the southern lawn, there are three trees immediately to the west of the path entrance that has barbed wire wrapped around them which is recommended to be removed.

Barbed wire
