## Proposed Waitomo District Plan

### **Attachment 1 - Submission to Proposed Waitomo District Plan**

Sudesh Machra – 1054 Mangarino Road, Hangatiki

# ARCHAEOLOGICAL INSPECTION & ASSESSMENT, PA/URUPA \$16/1 KAKAMORIA at HANGATIKI

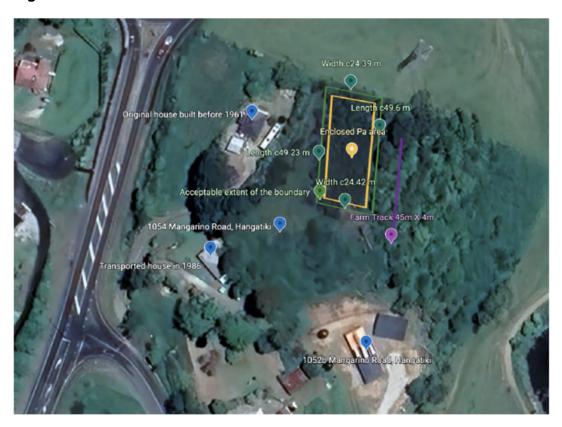
Figure 3

7. Ms Machra opposes the extent of the Area being sought under the proposed Waitomo District Plan. The Area sought by Ms Machra for the New Zealand Heritage List / Rārangi Kōrero and the <u>Proposed Plan</u> is shown below at Figure 3. The 'Yellow' lines show the area described in Dr Ritchie's assessment (referred to below). The 'Green' lines show the boundary of the area sought by Ms Machra in her submissions:

- 25. Ms Machra accepts that the rules and other provisions applying to Areas of Significance to Māori are appropriate for the area of significance proposed in Figure 3.
- 26. Ms Machra opposes those rules and provisions as they would apply to the Property if the delineation shown in the Proposed Plan (Figure 1) and/or in the HNZ submission to the heritage register are adopted. That is because the rules and other provisions would unreasonably infringe her use and enjoyment of the Property without any positive benefit to the relevant archaeological or heritage values.

- 30. The proposed area (Figure 3) for Ms Machra provides both for the protection of the pā/urupa and well as her retaining her property rights.

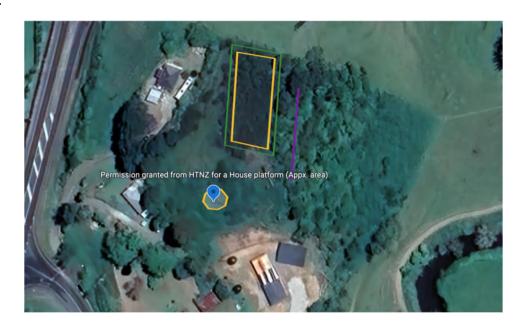
Figure 4

- (b) Vegetation was sought to be moved from the pā/urupa as pest species were growing, and a plan was developed on the best way to do this.
- (c) On the opinion regarding the house platform, permission for the dwelling was obtained and it was affirmed that works could operate on an Accidental Discovery Protocol basis, and information from Ms Machra was to be provided. This area is shown below:

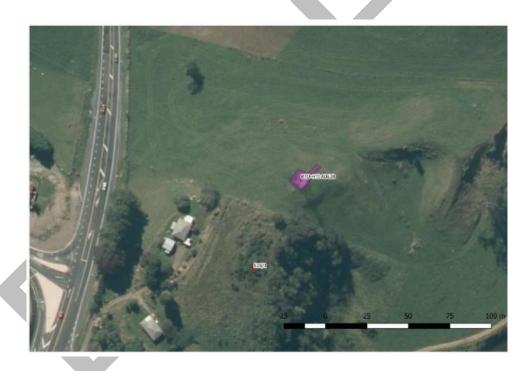
(Trilford, Plan of Works and Power Pylon, 2018)

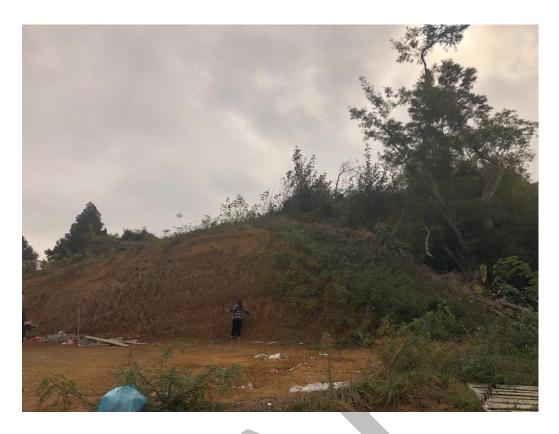
(Excavation, Ngāwhare May 2022)

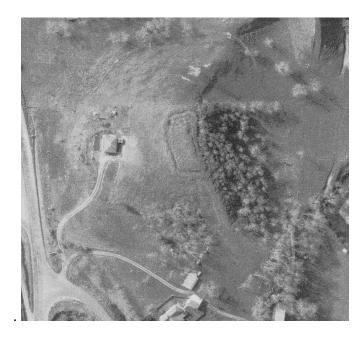
The extent of the pa/burial ground is clearly shown on a 1961 aerial photograph (accessible via Retrolens). It occupies a relatively small area on the top of the hill. This was confirmed on the ground during a site inspection on 21/11/22 by this author, accompanied by the landowner, Mrs. Machra. The extent of pa is usually based for legal, management and preservation purposes, on the outermost defensive trenches unless there is compelling evidence of other features associated with the pa in the vicinity. In practice, a small buffer zone is allowed around the margins depending on circumstances. Without a working definition, anyone could claim an archaeological site, particularly a habitation site like pa or kainga, are as extensive as it's in their interests to make them.

The extent of the pa/urupa is clearly visible on this 1961 aerial photo (from Retrolens)

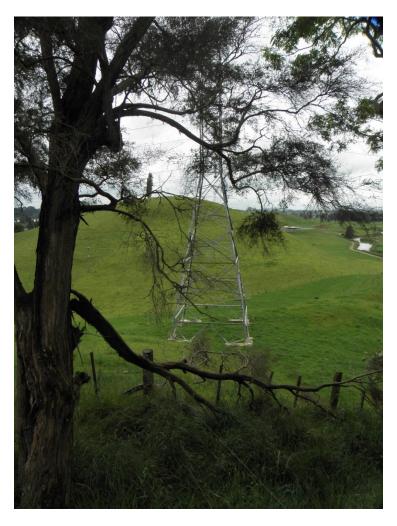
The transmission tower c29m north of the pa/urupa, and on an adjacent property. The boundary fence can be seen behind the fallen branches. (Photo. N Ritchie November 2022)

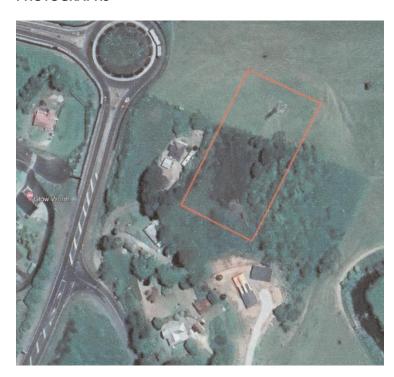
The proposed extent of the Kakamoria wahi tapu (Source HNZ List Nomination 9859)

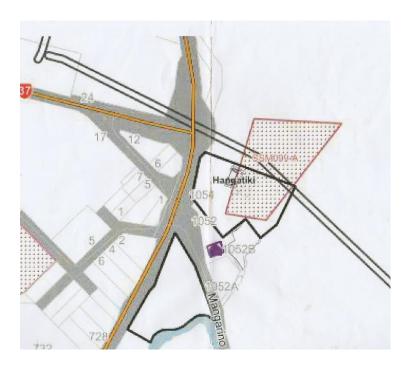
Proposed, even larger, extent of the wahi tapu area in the Waitomo District Council draft plan

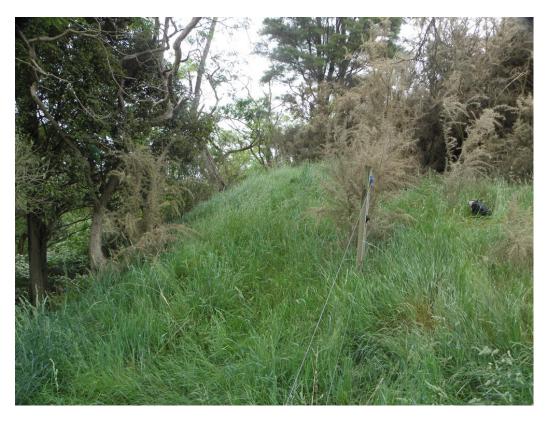
The terrace on the northeast side of the pa with steep drop off which was part of the pa's defenses

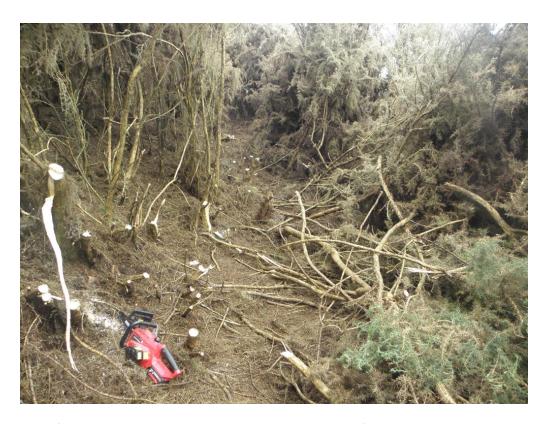
Part of the cut through the gorse on the southwest side of the pa to expose the ditch

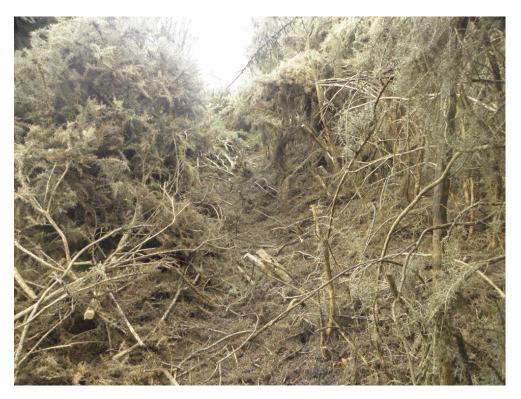
Another cut through the gorse on the south side. The pa is to the right

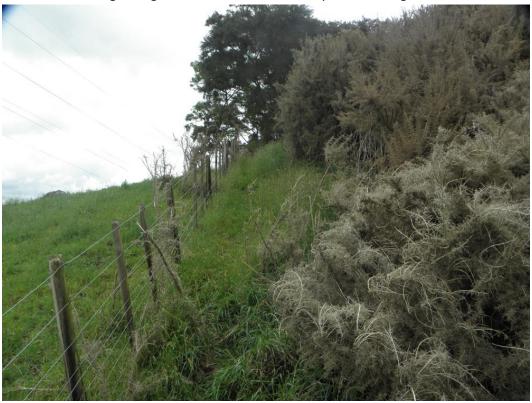
The boundary fence on the north side. The northern end of the pa is about 5m into the gorse on the right
