LABORATORY REPORT

To : Luke Kennedy
C4C Ticket number : 612952
Date : 30/08/2022
Customer Details : Waitomo District Council Site Building

Background

A request was made for the Dulux Innovation Centre to determine the presence of lead in dry paint flake samples. A number of flake samples taken from two different sites; site 1 – Waitomo District Council Offices and site 2 – Waitomo District Council I site building.

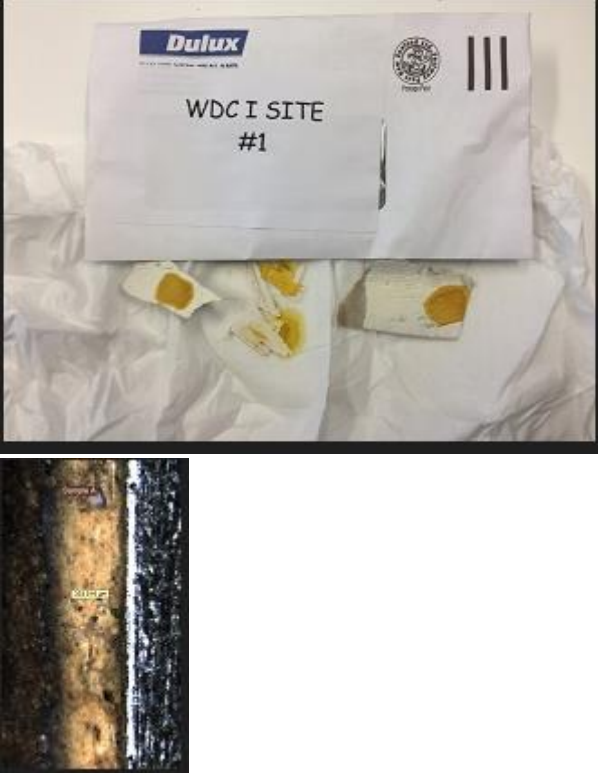
| FLAKE ID | FRONT | BACK | IN-BETWEEN | |
|---|---|---|--|--|
| Sample A | Negative | Negative | 1 layer only - negative | <p>The photograph shows the packaging for Sample A, which is a white envelope labeled 'WDC I SITE #1'. Below the envelope are two small, yellowish, irregularly shaped flakes. To the right of the envelope is a circular logo and three vertical bars. Below the main photograph is a vertical cross-section of the sample, showing a single, dark, textured layer.</p> |

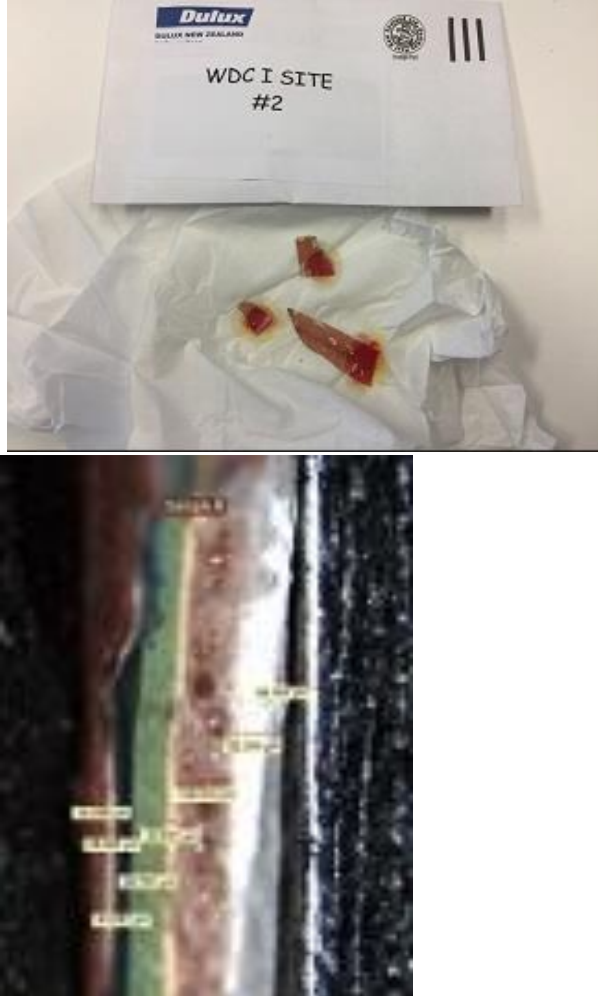
Lead was only detected on the back of Sample B. All other flakes appear to be lead free.

| FLAKE ID | FRONT | BACK | IN-BETWEEN | |
|---|---|---|--|--|
| Sample B | Negative | Positive | No obvious positive result between the front and back layer. | <p>The photograph shows the packaging for Sample B, which is a white envelope labeled 'WDC I SITE #2'. Below the envelope are several small, reddish-brown, irregularly shaped flakes. To the right of the envelope is a circular logo and three vertical bars. Below the main photograph is a vertical cross-section of the sample, showing multiple layers of different colors (green, red, white, black) with yellow arrows pointing to specific layers.</p> |

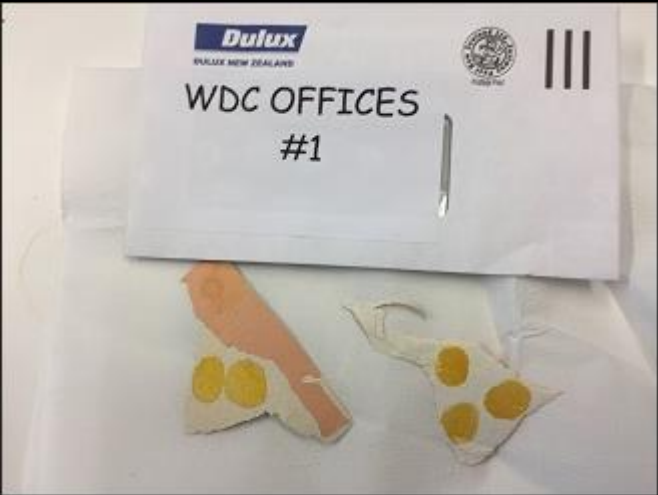
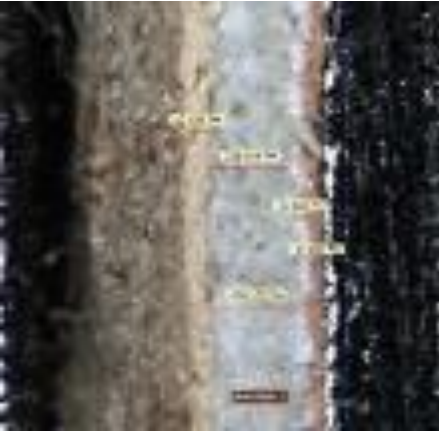
| <p>Sample 1</p> | <p>Negative</p> | <p>Negative</p> | <p>4 layers total – No obvious positive result between the front and back layer.</p> | |

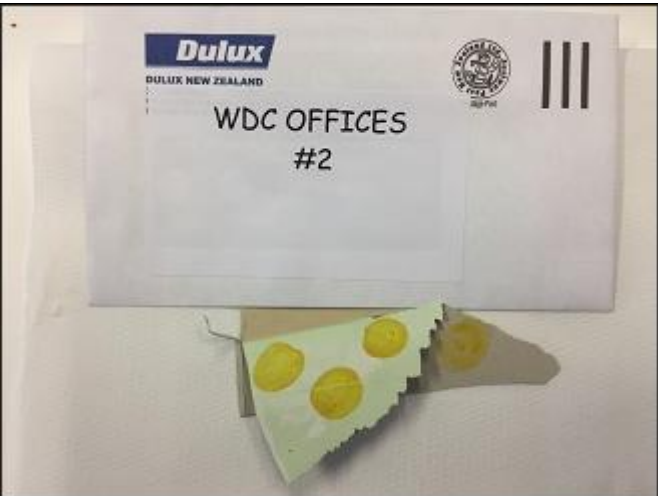
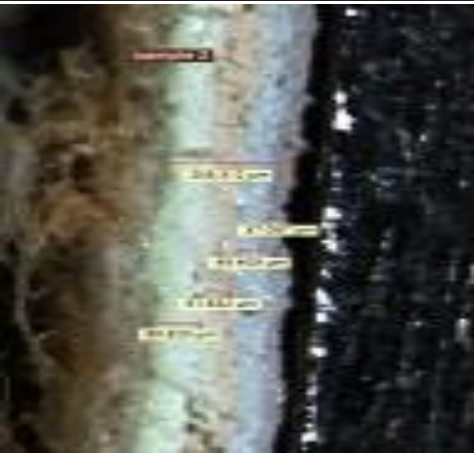
| <p>Sample 2</p> | <p>Negative</p> | <p>Negative</p> | <p>4 layers total – No obvious positive result between the front and back layer.</p> | |

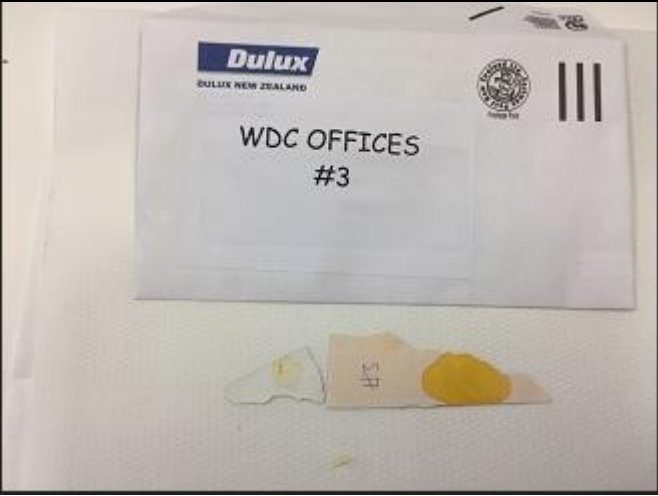
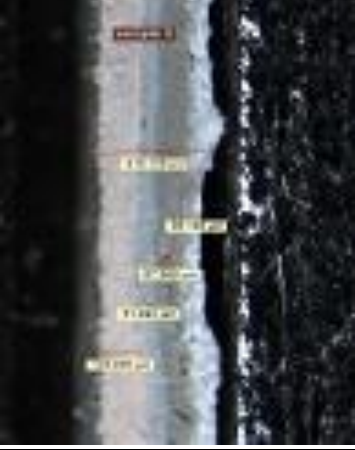
| Sample 3 | Negative | Negative | 4 layers total – No obvious positive result between the front and back layer. | |

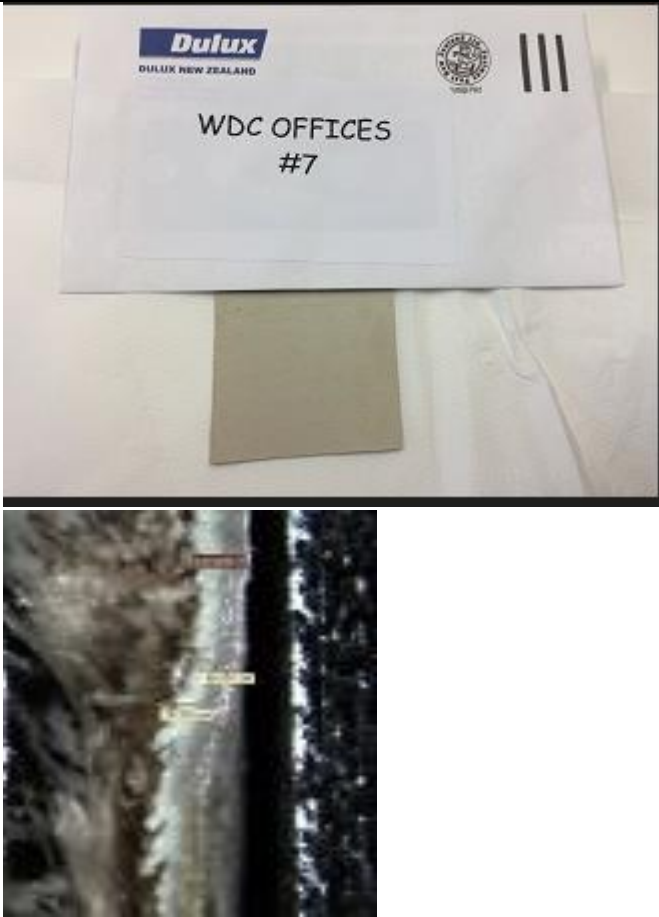
| <p>Sample 6</p> | <p>Negative</p> | <p>Negative</p> | <p>2 layers total – No obvious positive result between the front and back layer.</p> | <p>The photograph shows the front of a white envelope with the Dulux logo and 'DULUX NEW ZEALAND' printed at the top left. The address 'WDC OFFICES #7' is printed in the center. A circular postmark and three vertical bars are visible on the right side. Below the envelope is a small, rectangular, light-brown paper insert. The second image is a cross-section of the envelope, showing two distinct layers of paper with a dark, textured material between them. Yellow arrows point to the interface between the layers.</p> |

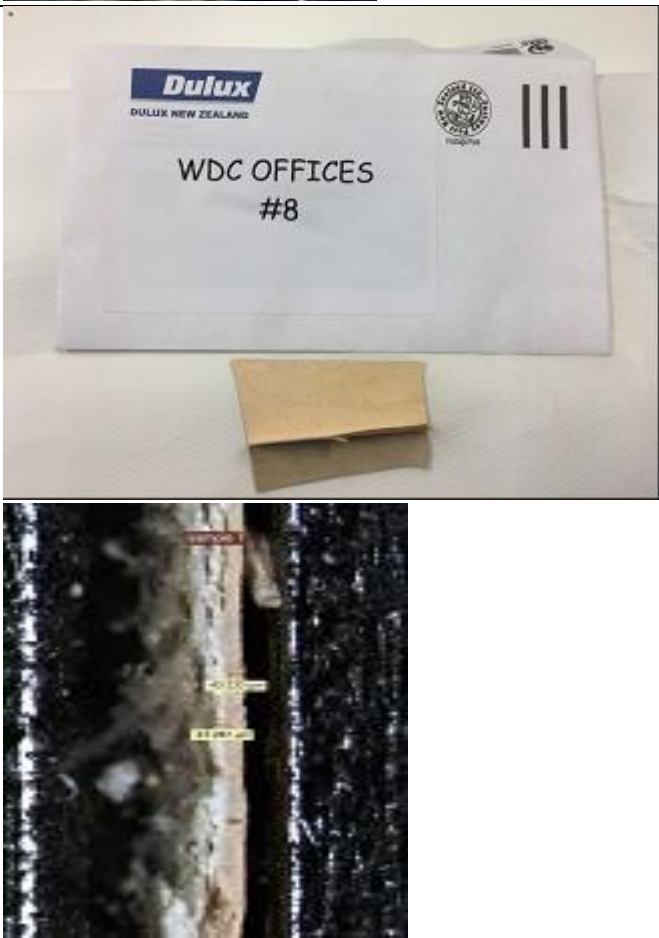
| <p>Sample 7</p> | <p>Negative</p> | <p>Negative</p> | <p>2 layers total – No obvious positive result between the front and back layer.</p> | <p>The photograph shows the front of a white envelope with the Dulux logo and 'DULUX NEW ZEALAND' printed at the top left. The address 'WDC OFFICES #8' is printed in the center. A circular postmark and three vertical bars are visible on the right side. Below the envelope is a small, rectangular, light-brown paper insert. The second image is a cross-section of the envelope, showing two distinct layers of paper with a dark, textured material between them. Yellow arrows point to the interface between the layers.</p> |
